**Flood Control Project Maintenance
Levee Inspections**

Maintenance Issue Types Only, Levee Inspection Report By Mile - Fall 2016

Reclamation District No. 0017 Mossdale

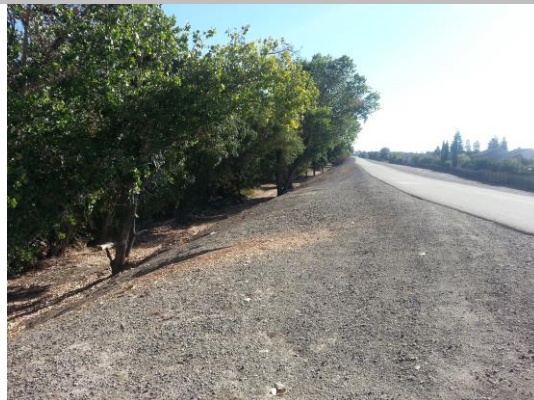
Photo 1 of 1 : FA_2016_RD0017_303_6_20161006_00016.jpg

Looking south typical view of waterward slope.

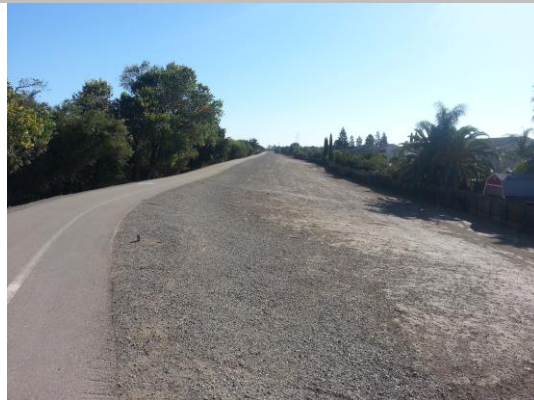
Photo 1 of 1 : FA_2016_RD0017_303_10_20161006_00017.jpg

Looking south at typical view of landward slope.

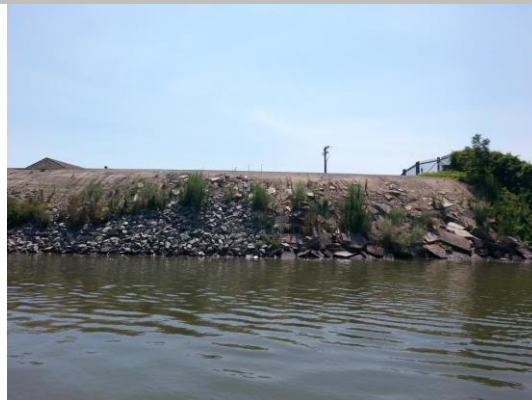
Photo 1 of 2 : SJR2016_RD0017U02RM44.32_1.jpg

LM Start	1.08	Rating **	U	Issue No.	2	
LM End	1.08	Issue Type +	Ma	Location *	WS	
Category	Supplemental			GPS Latitude/Longitude		
				Start	End	
Item	DWR Erosion Survey			37.902530°	37.902530°	
				-121.325690°	-121.325690°	
DWR ID						
Comment Code						
Inspector Comment						
07/25/2016: No significant change observed.						
06/24/2015: No significant change observed.						
06/19/2014: No significant change observed.						
08/13/2013: No significant change at this site.						
08/07/2012: The erosion is nearly vertical, and has developed upward						
to halfway of the levee slope. The protecting concrete blocks have been						
washed away. Animal activities are visible. [2016 Site						
ID:RD0017U02RM44.32]

Front view of the erosion site. Note the concrete blocks and vegetation at the site.

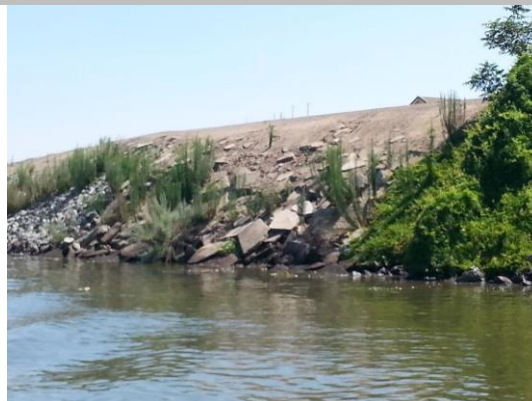
Photo 2 of 2 : SJR2016_RD0017U02RM44.32_2.jpg

LM Start	1.08	Rating **	U	Issue No.	2 (cont)	
LM End	1.08	Issue Type +	Ma	Location *	WS	
Category	Supplemental			GPS Latitude/Longitude		
				Start	End	
Item	DWR Erosion Survey			37.902530 °	37.902530 °	
				-121.325690 °	-121.325690 °	
DWR ID						
Comment Code						
Inspector Comment						
07/25/2016: No significant change observed. 06/24/2015: No significant change observed. 06/19/2014: No significant change observed. 08/13/2013: No significant change at this site. 08/07/2012: The erosion is nearly vertical, and has developed upward to halfway of the levee slope. The protecting concrete blocks have been washed away. Animal activities are visible. [2016 Site ID:RD0017U02RM44.32]

Close view of the erosion.

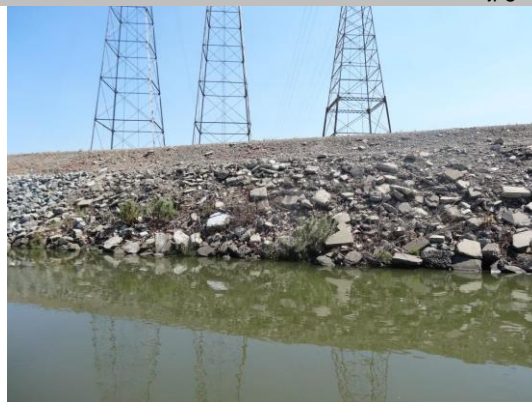
Photo 1 of 2 : SJR2016_RD0017U02RM46.1_1.jpg

LM Start	2.82	Rating **	M	Issue No.	83
LM End	2.82	Issue Type +	Ma	Location *	WS
Category	Supplemental			GPS Latitude/Longitude	
				Start	End
Item	DWR Erosion Survey			37.878660 °	37.878660 °
				-121.332400 °	-121.332400 °
DWR ID					
Comment Code					
Inspector Comment					
07/25/2016: No significant change observed.					
06/24/2015: No significant change observed.					
06/19/2014: A pocket erosion was found during the boat survey. [2016					
Site ID:RD0017U02RM46.1]

Front view of the erosion.

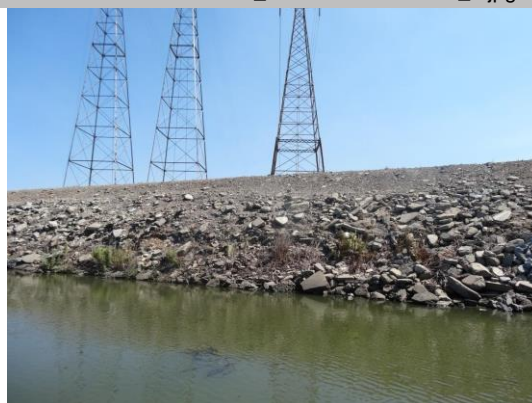
Photo 2 of 2 : SJR2016_RD0017U02RM46.1_3.jpg

Close view of the erosion. The slope protection is poor.

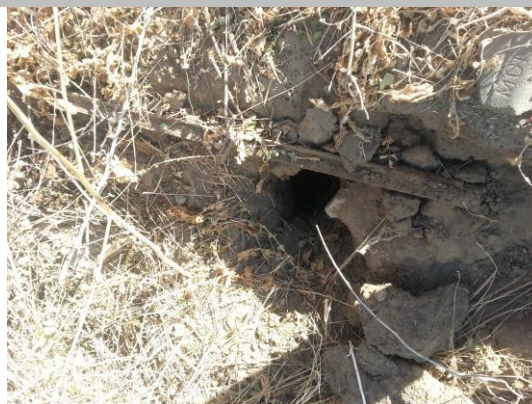
Photo 1 of 2 : FA_2016_RD0017_304_75_20161006_00202.jpg

LM Start	3.73	Rating **	U	Issue No.	75
LM End	3.73	Issue Type +	Ma	Location *	WS
Category	Earthen Levee			GPS Latitude/Longitude	
				Start	End
Item	Animal Control			37.867233°	37.867233°
				-121.326712°	-121.326712°
DWR ID	DWR_RD0017_02_f_2016_75				
Comment Code					
A3 : No rodents visible, but rodent burrows visible; need to backfill and compact or grout burrows.					
Inspector Comment					
Large breaver holes on waterward berm

Looking east at beaver den on waterward slope.

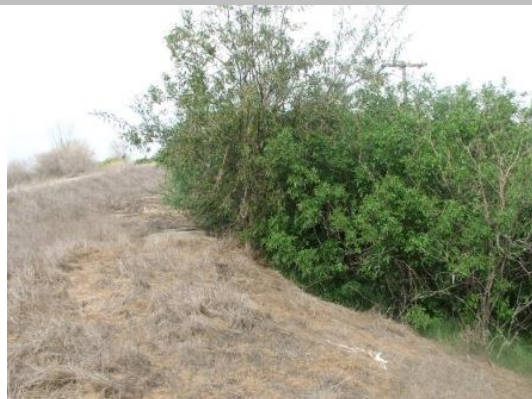
Photo 1 of 1 : FA_2016_RD0017_304_25_20160929_00013.jpg

LM Start	7.58	Rating **	M	Issue No.	25
LM End	7.60	Issue Type +	Ma	Location *	LS
Category	Earthen Levee			GPS Latitude/Longitude	
				Start	End
Item	Vegetation			37.828095 °	37.827920 °
				-121.309945 °	-121.309847 °
DWR ID	DWR_RD0017_02_s_2012_25				
Comment Code					
V4 : Elderberries are blocking visibility and flood fight capability.					
Inspector Comment

Elderberry blocking view of landside slope and toe.
